**Flood Control Project Maintenance
Levee Inspections**

Maintenance Issue Types Only, Levee Inspection Report By Mile - Spring 2018

Reclamation District No. 1500 Sutter Basin

Waterway	Bank	Unit Miles	Inspection Start/End	Inspector
Unit No. 01 Sacramento River	Left	33.15	03/27/2018 03/28/2018	Zach Jojola

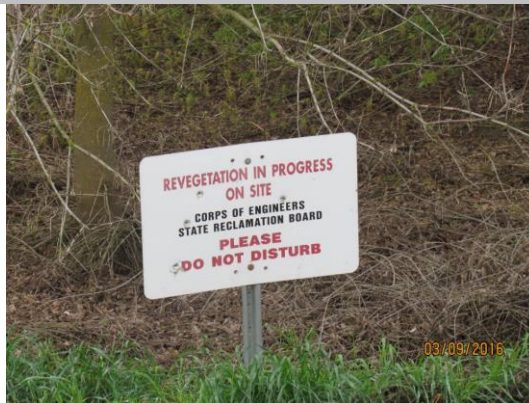
Photo 2 of 2 : SP_2018_RD1500_189_72_20180306_00040.jpg

LM Start	0.56	Rating **	A/W	Issue No.	72 (cont)
LM End	0.82	Issue Type +	Ma	Location *	WS
Category	Earthen Levee			GPS Latitude/Longitude	
				Start	End
Item	Vegetation			38.764462 °	38.764638 °
				-121.683167 °	-121.687690 °
DWR ID	DWR_RD1500_01_s_2018_72				
Comment Code					
V8 : Environmental Requirements.					
Inspector Comment

Sign is located at the toe of the levee on the waterward side. Spring 2016.

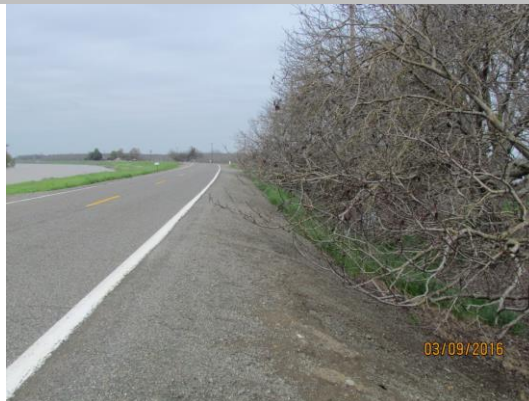
Photo 1 of 1 : SP_2018_RD1500_189_217_20180306_00082.jpg

LM Start	7.15	Rating **	M	Issue No.	217
LM End	7.15	Issue Type +	Ma	Location *	LS
Category	Earthen Levee			GPS Latitude/Longitude	
				Start	End
Item	Trim / Thin Trees			38.824119 °	38.824119 °
				-121.722776 °	-121.722776 °
DWR ID	DWR_RD1500_01_s_2018_217				
Comment Code					
T1 : Trim trees to at least five feet above ground level.					
Inspector Comment

View of the trees on the landward side of the levee looking upstream. Spring 2016.

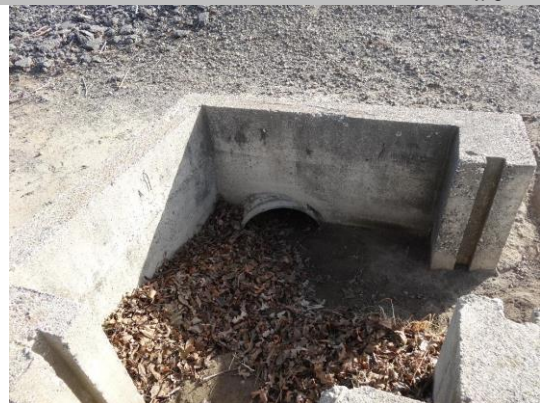
Photo 2 of 3 : UCIP_SP_2018_50197_52424.jpg

FS_ID:50197
DS_ID:20063
EP_NO: 10061
Repair Type: Non-Urgent
Crossing Status: Found
UCIP Comments: 08/29/2016 Same as last inspection. (K. Fazel - UCIP)01/10/2014 Needs proper abandonment. (P. Amatya - DWR)
FIELD_STRUCT_DESC: *ABANDONED* 18-inch corrugated metal gravity drainage pipe through the levee, 15 feet below the crown. Slide gate in a 4-foot by 4-foot concrete box at the waterside (WS) toe. Concrete box at the landside (LS) toe. Pipe crosses overflow area to the river. Installed by USACE in 1944. (18-inch corrugated metal gravity drainage pipe through the levee and all other appurtenances retained under Automatic Board Order (ABO) issued as Permit No. 10061, 1974 - Roger L. Matteoli). [Additional Reference(s): DWR Levee Log, 2005. USACE Sacramento O&M Manual 128, March 1960, (HLM 12.69)].
FS Date: 8/29/2016

LS view: concrete intake box on levee toe.

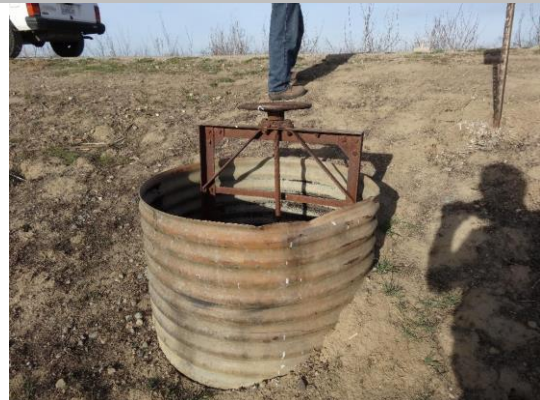
Photo 1 of 3 : UCIP_SP_2018_50196_52467.jpg

Comment Code					
Inspector Comment					
FS_ID:50196 DS_ID:20011 EP_NO: 9337 Repair Type: No Action Needed Crossing Status: Found UCIP Comments: 08/29/2016 As it currently stands, there is no connection to the river, as, according to LMA, this pipe is used for irrigation of WS fields. (K. Fazel - UCIP)01/10/2014 No pipe found on river bank. (P. Amatya - DWR) FIELD_STRUCT_DESC: 24-inch corrugated metal gravity irrigation pipe through the levee, 16 feet below the crown. Slide gate in a 36-inch corrugated metal pipe (CMP) riser on the waterside (WS) slope. Slide gate on a concrete U-shaped headwall at the landside (LS) toe. Per LMA, water is pumped into the LS canal via a LS pump upstream of the crossing. Water then flows through the CMP crossing by gravity for irrigation of WS fields. Permit is forthcoming with Dave Burrows of Winsept Farms as the applicant. (24-inch corrugated metal gravity irrigation pipe through the levee and all other appurtenances retained under Automatic Board Order (ABO) issued as Permit No. 9337, 1973 - Clauss [permit missing]). [Additional Reference(s): DWR Levee Log, 1990. USACE Sacramento O&M Manual 128, March 1960, (HLM 15.89)]. FS Date: 8/29/2016

WS view: CMP riser with slide gate on levee slope.

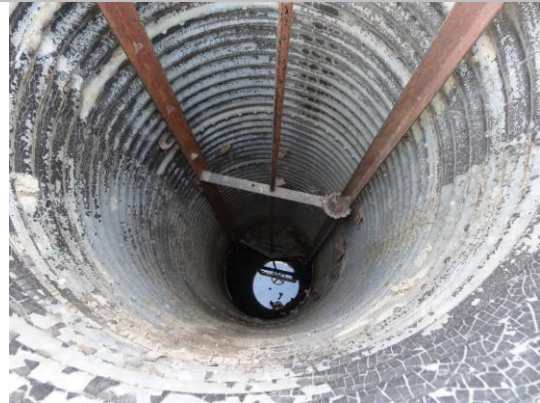
Photo 2 of 3 : UCIP_SP_2018_50196_52466.jpg

WS view: inside view of CMP riser with slide gate.

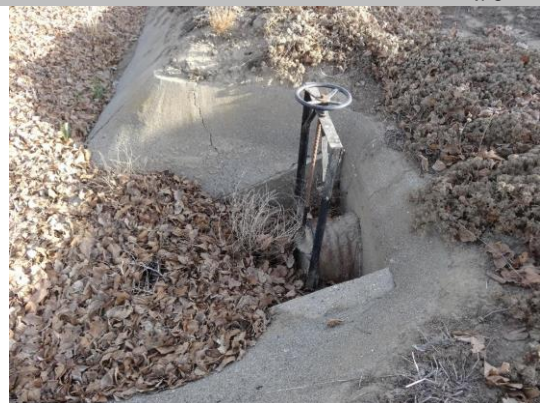
Photo 3 of 3 : UCIP_SP_2018_50196_52465.jpg

LS view: CMP outlet with slide gate and U type headwall on levee toe.

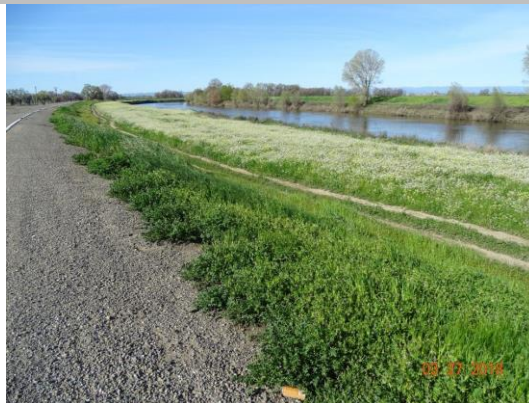
Photo 1 of 1 : SP_2018_RD1500_189_95_20180329_00232.jpg

LM Start	28.18	Rating **	M	Issue No.	95
LM End	31.53	Issue Type +	Ma	Location *	WS
Category	Earthen Levee			GPS Latitude/Longitude	
				Start	End
Item	Vegetation			38.982460 °	39.006748 °
				-121.819955 °	-121.814709 °
DWR ID	DWR_RD1500_01_s_2018_95				
Comment Code					
V1 : Control annual grass and weeds on the levee slopes and easements.					
Inspector Comment

View of vegetation on the waterside slope. Spring 2018

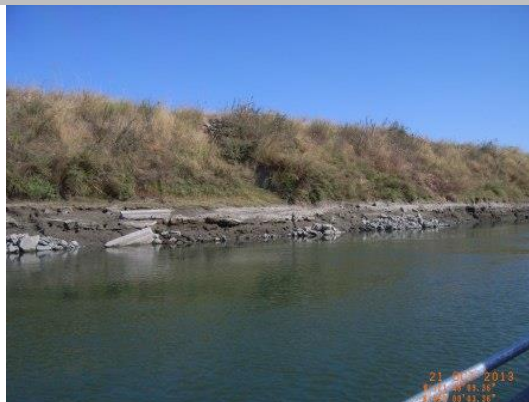
Photo 1 of 1 : SP_2018_RD1500_189_22_20180306_00020.jpg

LM Start	30.60	Rating **	A/W	Issue No.	22
LM End	30.75	Issue Type +	Ma	Location *	WS
Category	Supplemental			GPS Latitude/Longitude	
				Start	End
Item	2015 USACE Erosion Survey, DRAFT			38.999745 °	39.001413 °
				-121.800898 °	-121.802889 °
DWR ID	DWR_RD1500_01_s_2016_22				
Comment Code					
Inspector Comment					
2000 - Eroding, vertical berm slope over a vertical cohesive toe; slow erosion but getting close to the toe. 2002 - Erosion is getting close to the levee, still eroding with some new small slumps. 2004 - Some minor new erosion. 2006 - Some new erosion, cleaned off older scars and slump faces. 2008 - New, small, partial rotational failure. 2011 - Some new minor erosion. 2015: No observed changes. [2015 Site ID: SAC_116-0_L]

USACE 2013 Photo #1

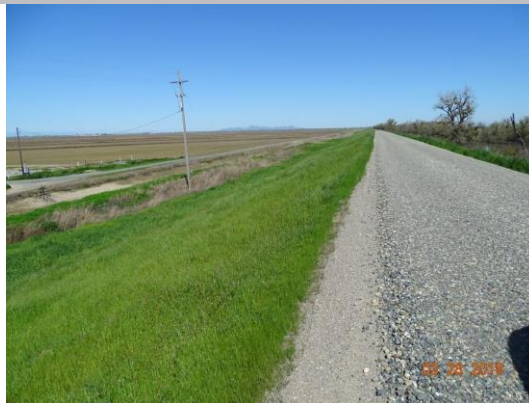
Photo 1 of 1 : SP_2018_RD1500_190_16_20180329_00041.jpg

LM Start	0.07	Rating **	M	Issue No.	16
LM End	9.97	Issue Type +	Ma	Location *	LS
Category	Earthen Levee			GPS Latitude/Longitude	
				Start	End
Item	Vegetation			38.761838 °	38.895132 °
				-121.673713 °	-121.636992 °
DWR ID	DWR_RD1500_02_s_2018_16				
Comment Code					
V1 : Control annual grass and weeds on the levee slopes and easements.					
Inspector Comment

View of vegetation on the landside slope. Spring 2018.

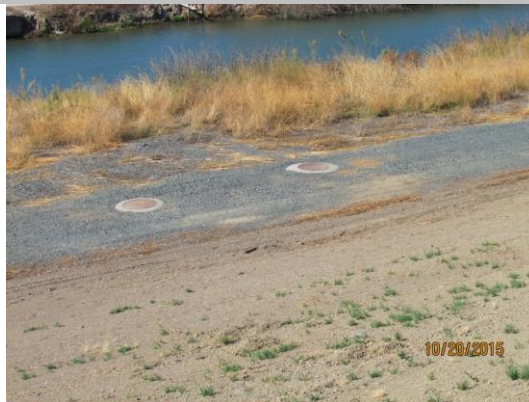
Photo 1 of 2 : SP_2018_RD1500_190_13_20180306_00006.jpg

LM Start	18.17	Rating **	A/W	Issue No.	13
LM End	18.17	Issue Type +	Ma	Location *	LS
Category	Earthen Levee			GPS Latitude/Longitude	
				Start	End
Item	Underseepage Relief Wells			38.987031 °	38.987031 °
				-121.725049 °	-121.725049 °
DWR ID	DWR_RD1500_02_s_2012_13				
Comment Code					
Inspector Comment

Two of four drains on the landward side of the levee. Fall 2015.
